**Final Report  
for Remediation of  
Locations in Granite  
City, Madison and  
Venice, Illinois,  
Associated with NL  
Industries/Taracorp  
Superfund Site**

**FINAL REPORT FOR REMEDIATION OF  
LOCATIONS IN GRANITE CITY, MADISON  
AND VENICE, ILLINOIS, ASSOCIATED  
WITH NL INDUSTRIES/TARACORP  
SUPERFUND SITE**

**Rapid Response Contract No. DACW45-89-D-0516  
Delivery Order No. 58**

*March 27, 1996  
Project 13407.2*

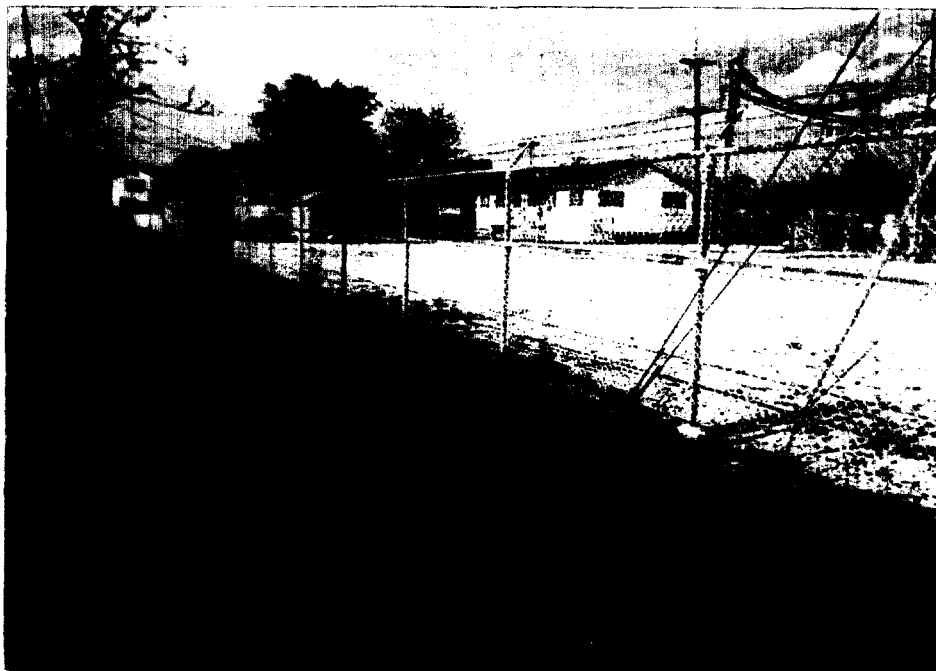
Looking up the alley from substation end before excavation and after set up of alley.

Alley #53 represent the typical work effort for all alleys. The fence delineates the excavation area. The progress of work is explained below and typifies all alleys in Phase 3.

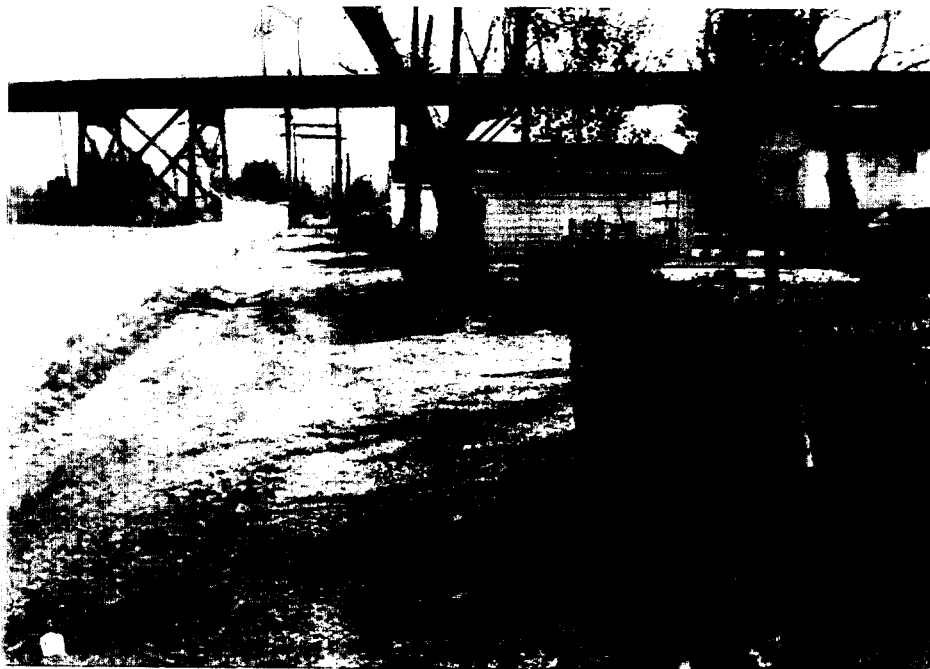
2. Looking down the alley from the other end before excavation and after seal up of alley

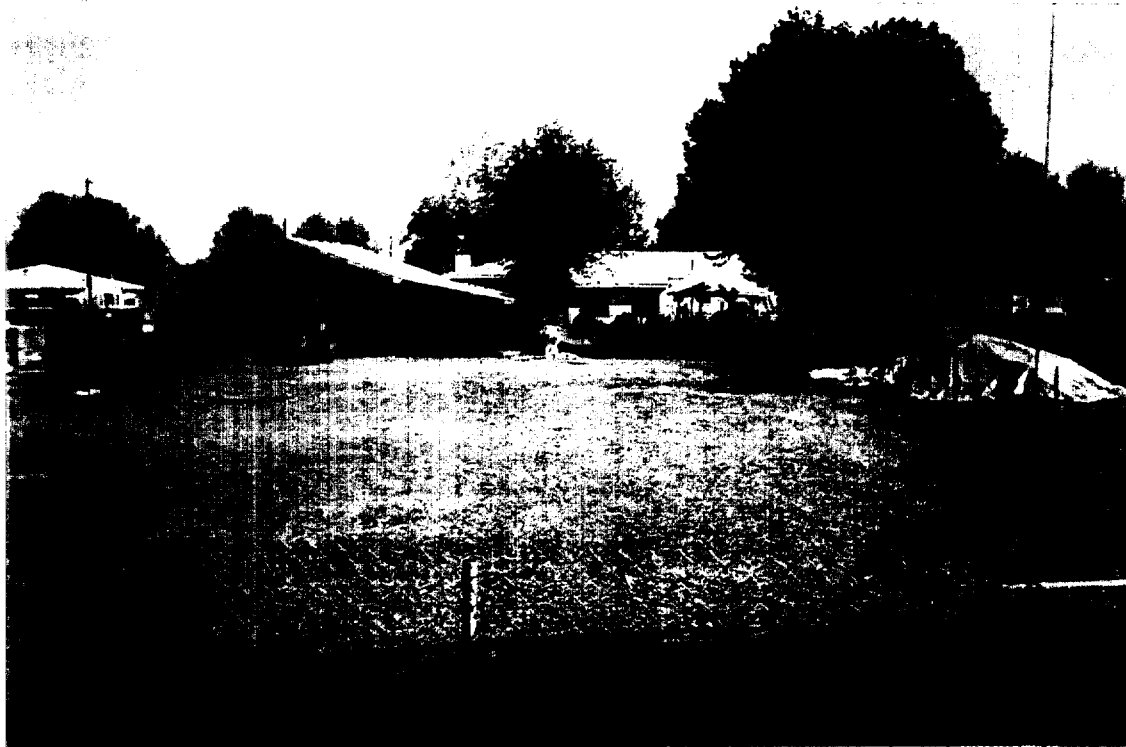
1 Hand excavation around building.

The 101 Carver site displays the excavation of hazardous materials from residential sites. The non-typical portion of this lot was placement of geotextile liner to cover the landfill debris found after original excavation depth. Otherwise, this site typifies Phase 1 work.

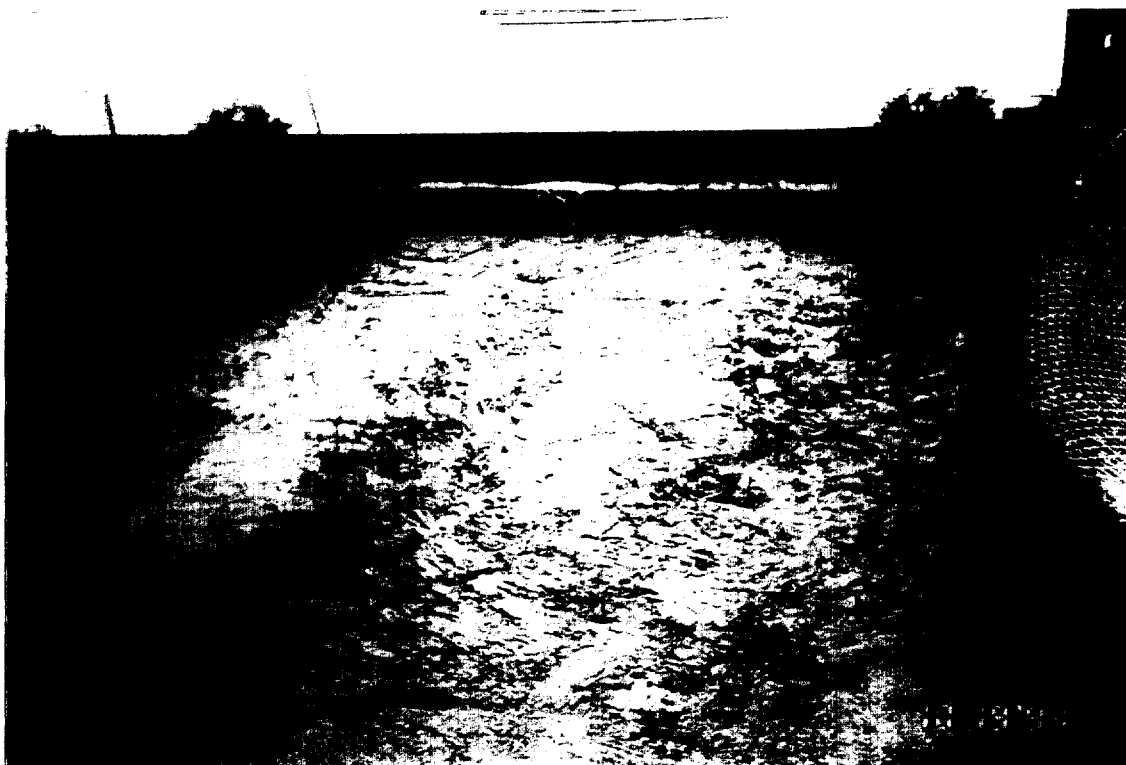
2 Front yard excavated, stockpiling soil at the rear of the lot.

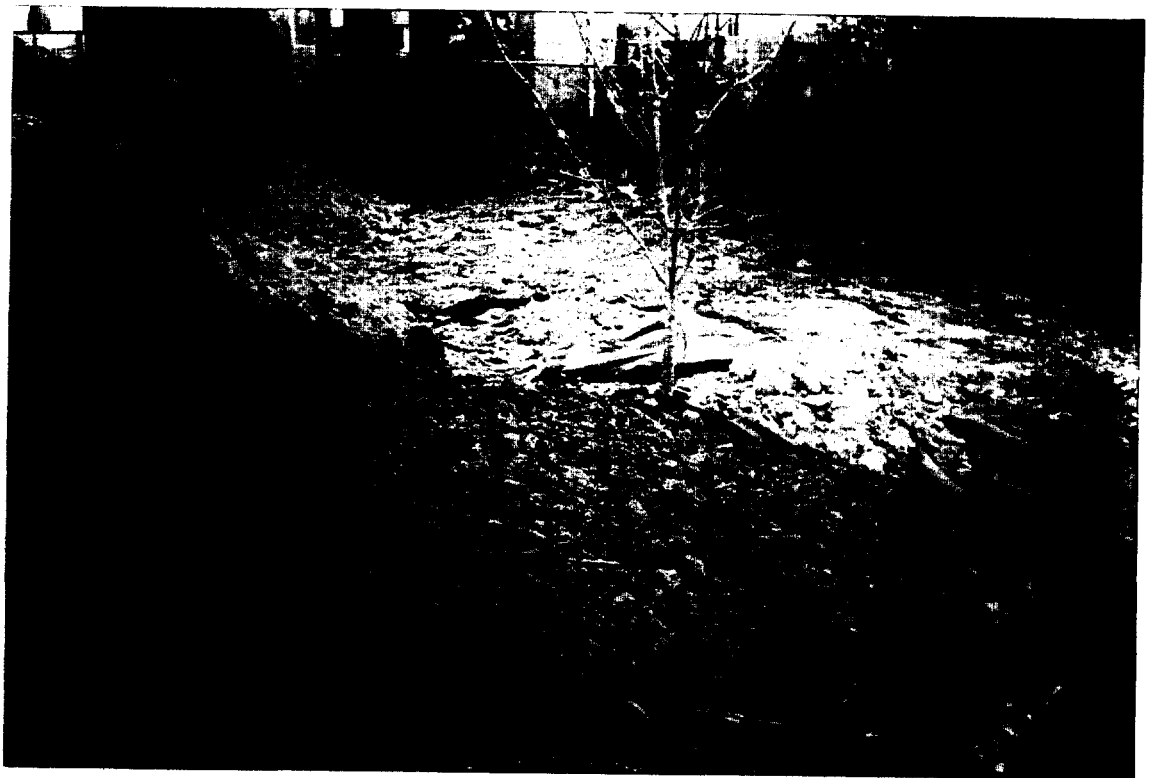
3. Geotextile liner over landfill with clay stockpiled for cap.

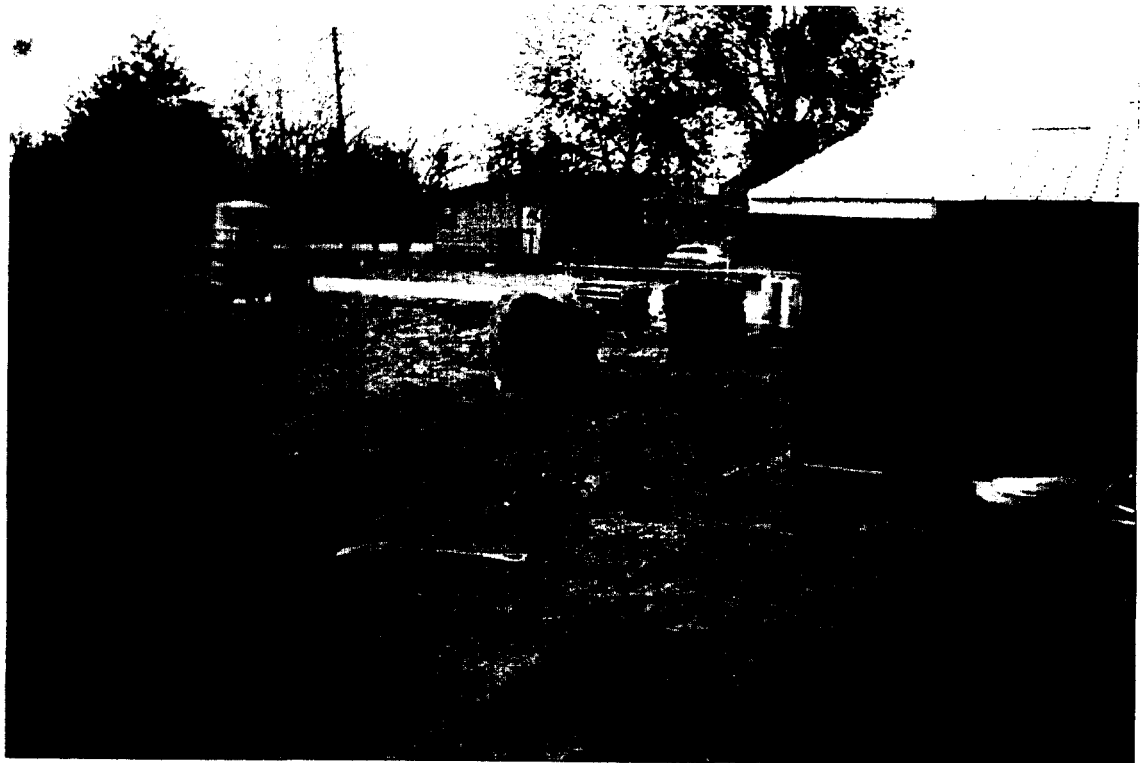
4. Final grading complete and sod being installed.

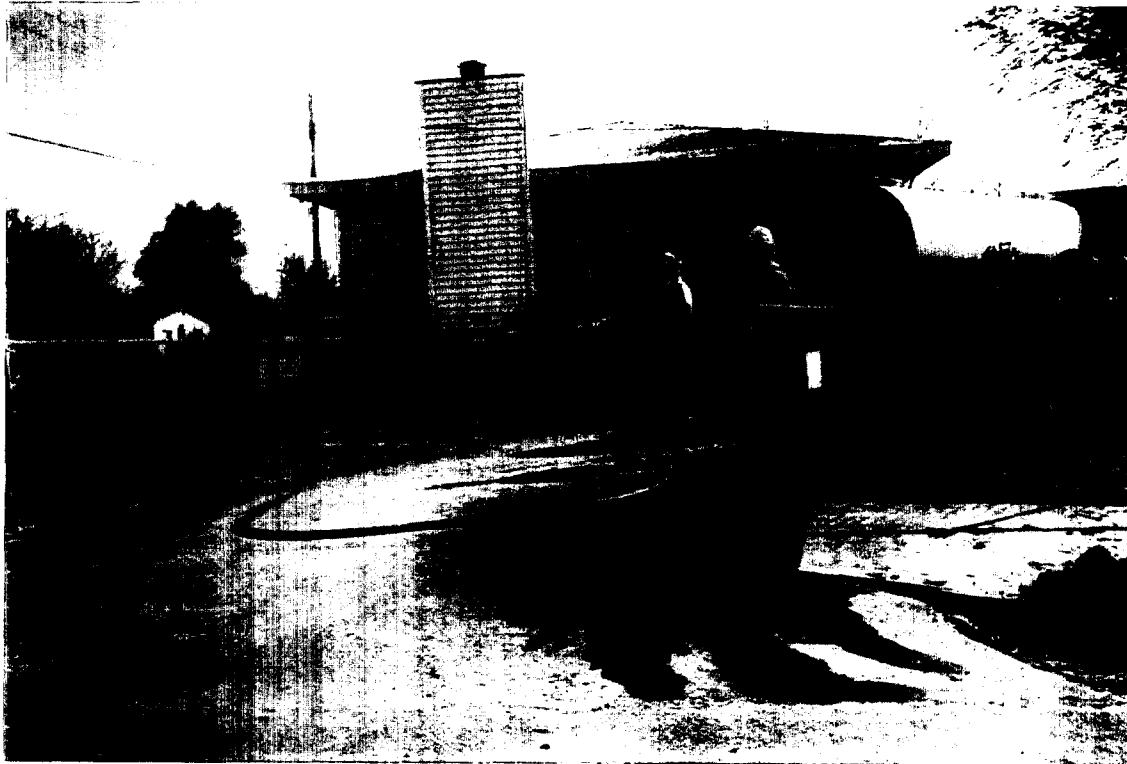
5 Munie Outdoor Construction watering after they installed sod.

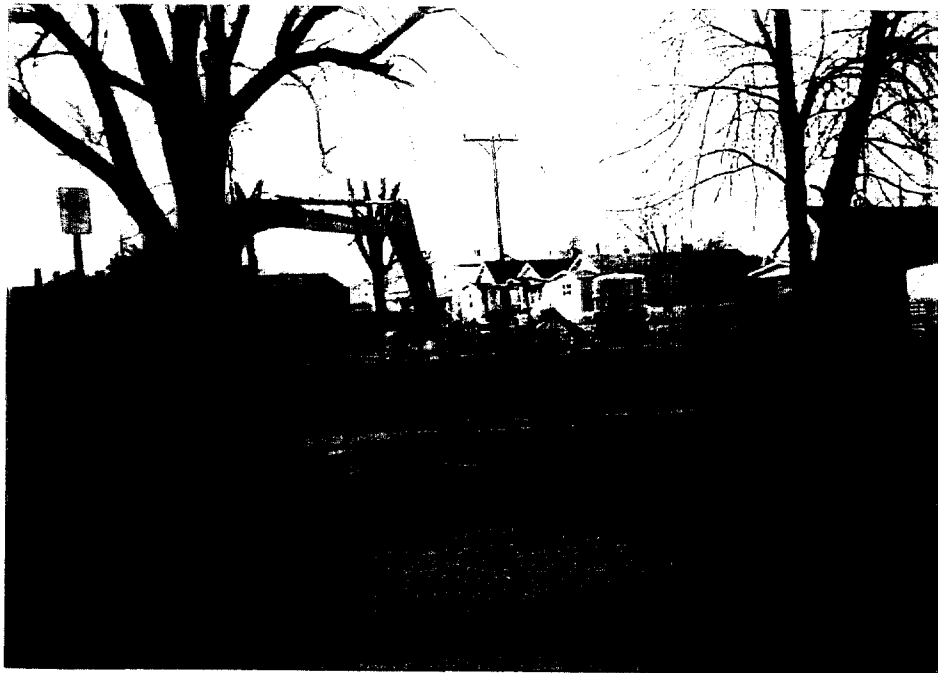
1 Equipment staged on site over Christmas break, before the excavation started.

The 1444 Grand site was a typical stack emissions lot showing progress from start to finish. This site typifies work for Phase 2.

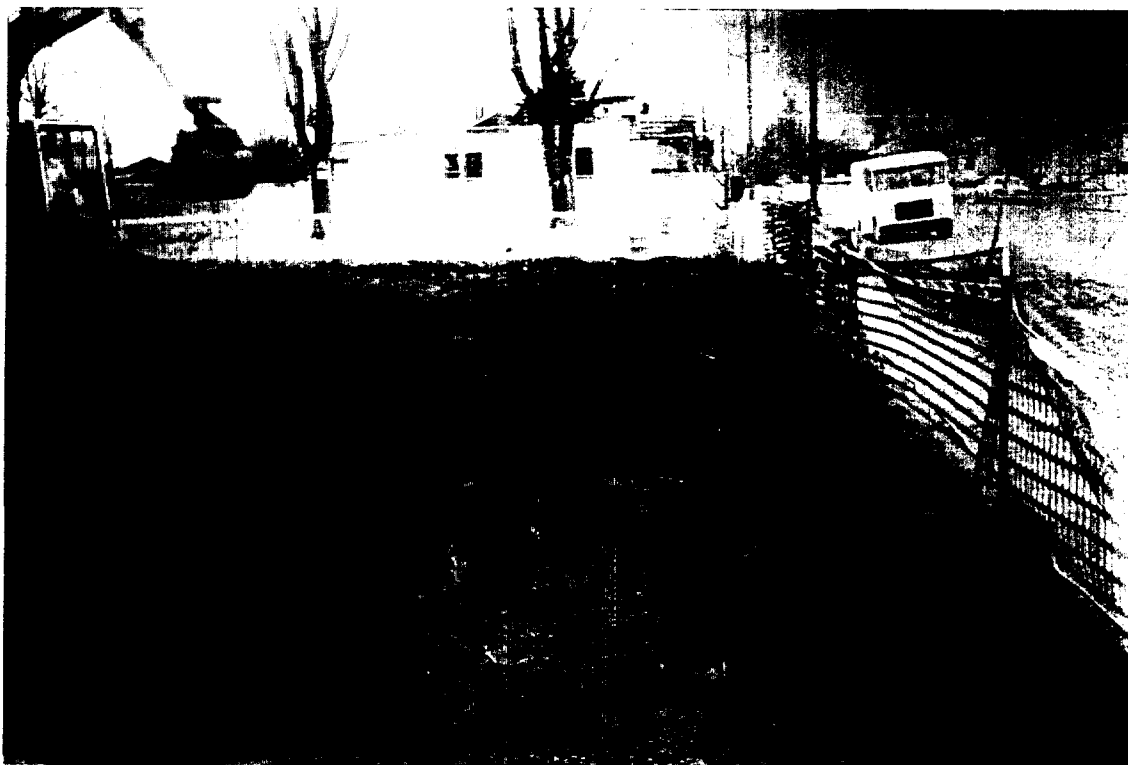
2 Front of lot being excavated.

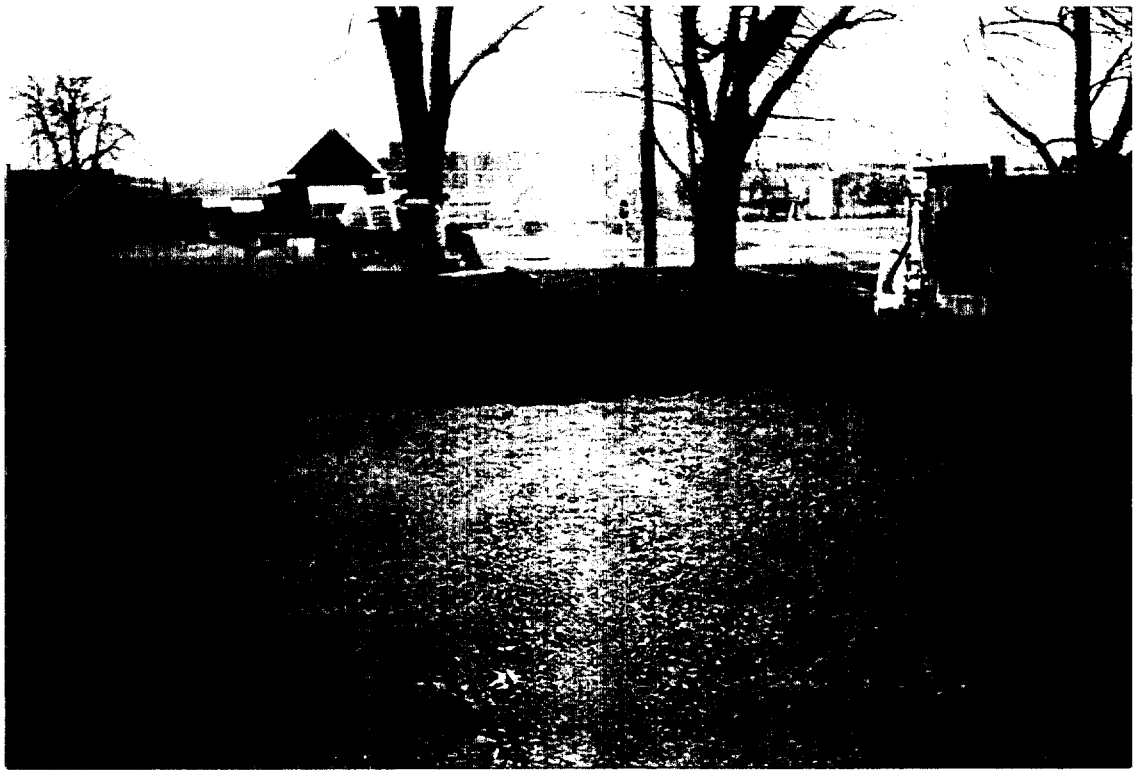
3. Topsoil being spread over backfill soil and final grading

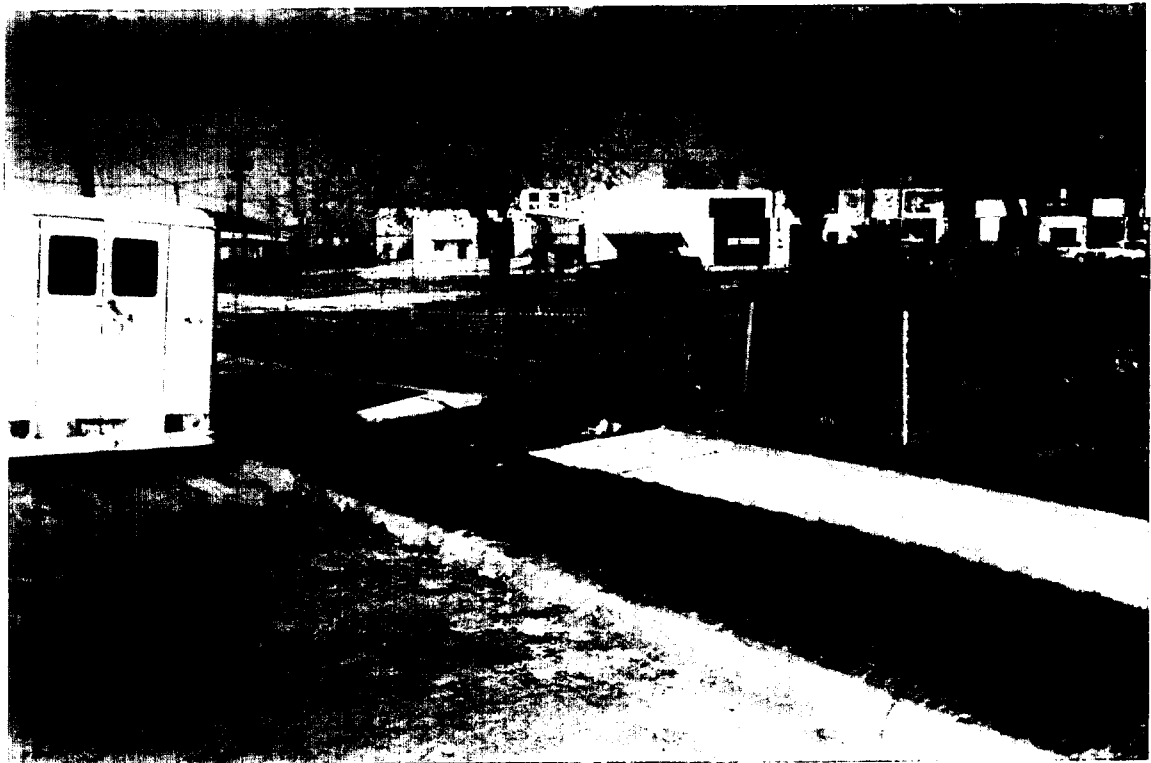
4. Not solidified 100%. City sidewalk broken during restoration being replaced.

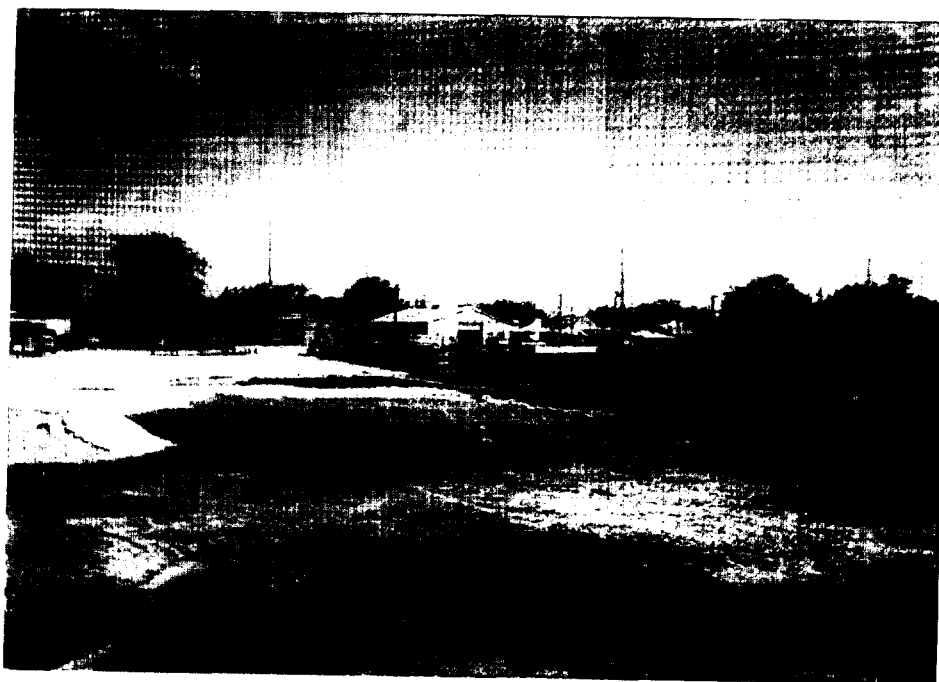
2. Subcontractor installing asphalt pad and berms for stabilization process equipment.

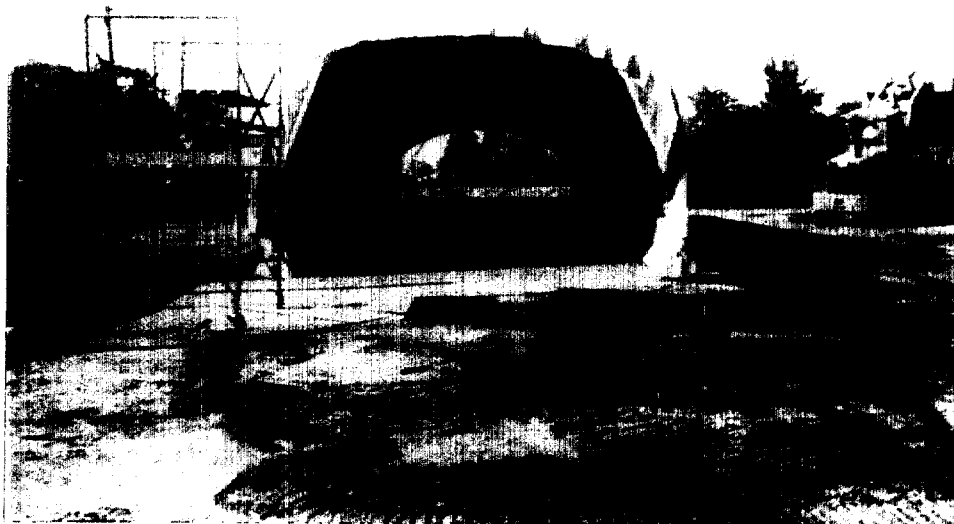
5. Building that was erected for the storage of hazardous soils.

A small pre-manufactured structure was erected on the hazardous side of the storage pad for containment of hazardous soil prior to the stabilization process. The temporary storage structure was structurally sound during inclement weather. Due to the productivity of the pugmill, some hazardous soil had to be stored outside the building and was protected from the wind and rain by inert foam material.

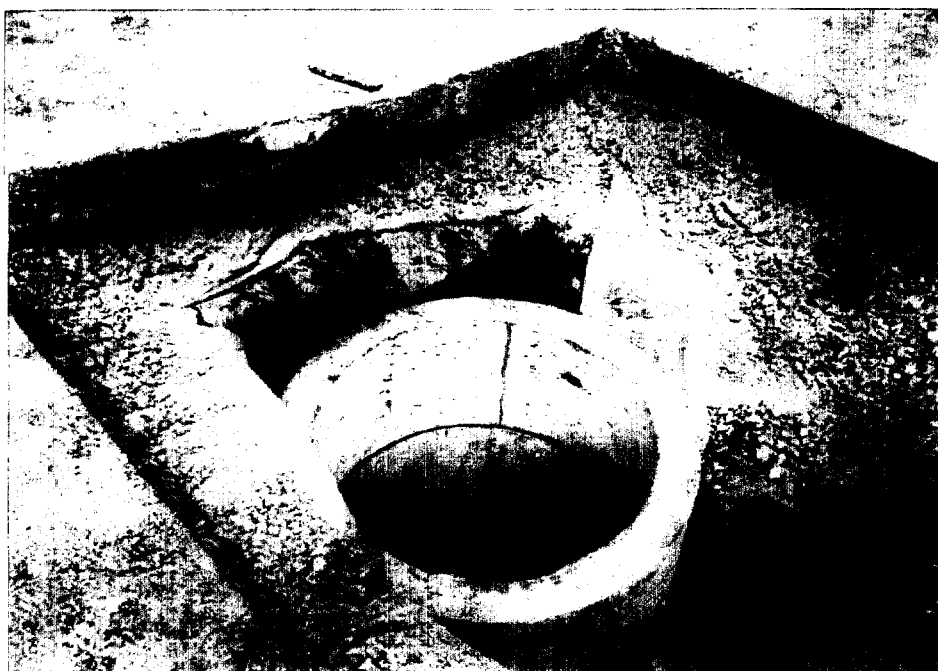
6. Installation of sump on the hazardous side of pad to contain rain water and act as a pumping station.

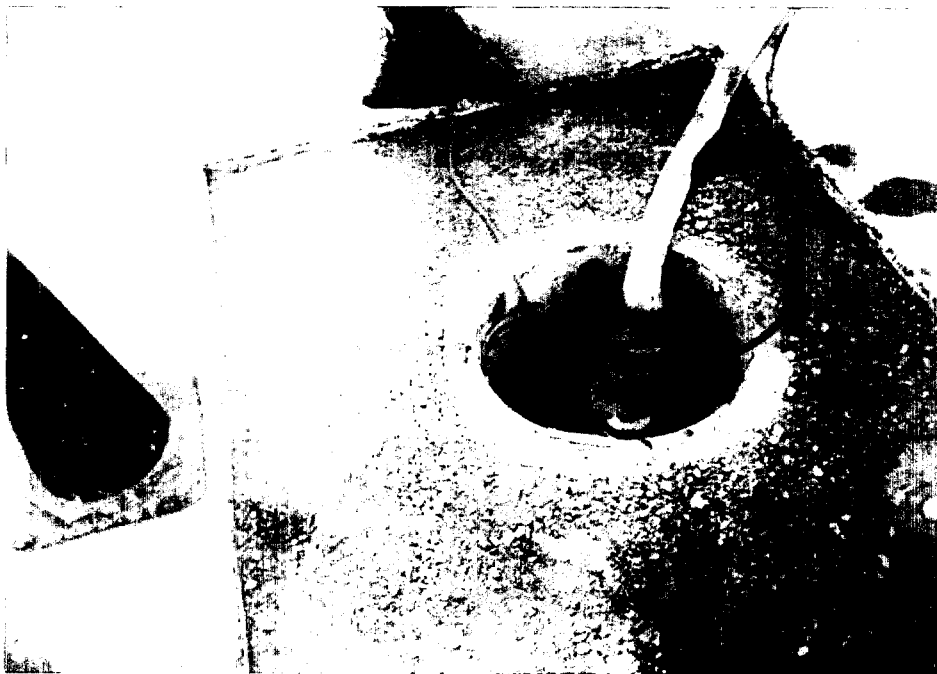
7. Sump completed before asphalt was installed around sump.

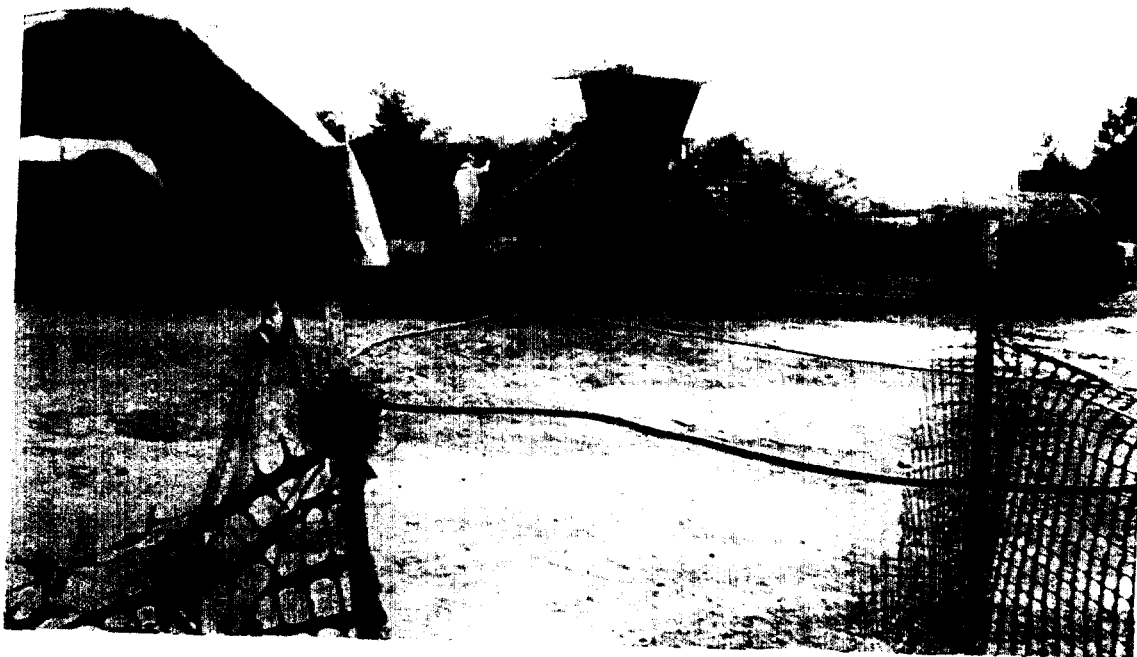
8. Crusher set up and running pilot test for hazardous slag pile.

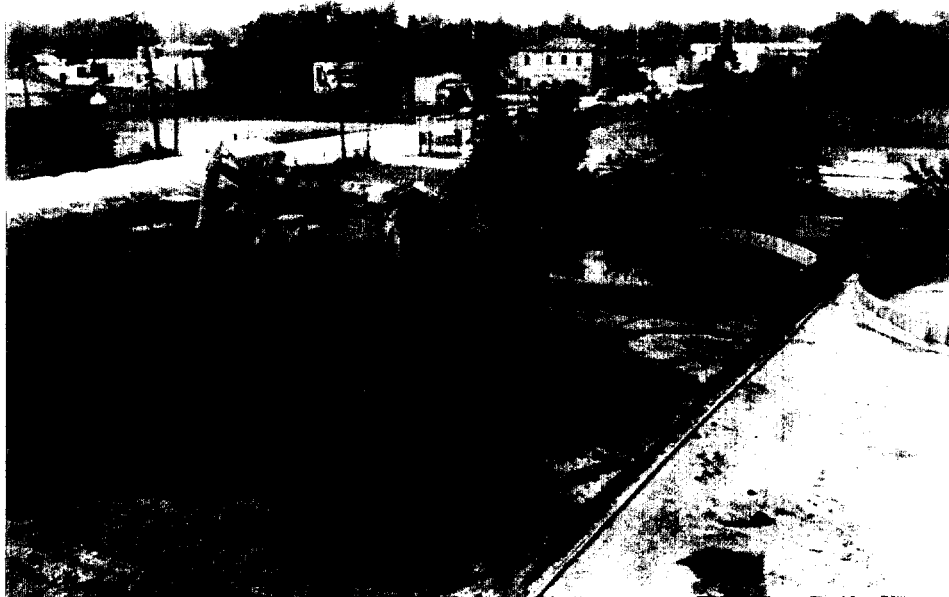
9. 644 Loader stockpiling for the trackhoe. PC220 Trackhoe running hazardous soils through power screen unit.

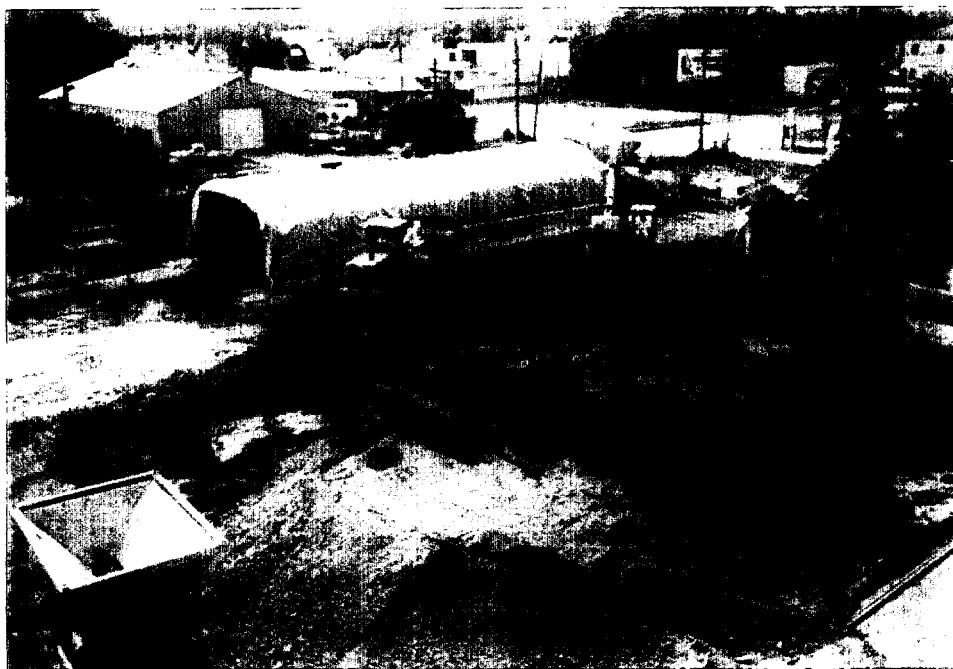
10. Overhead view of hazardous side of pugmill site.

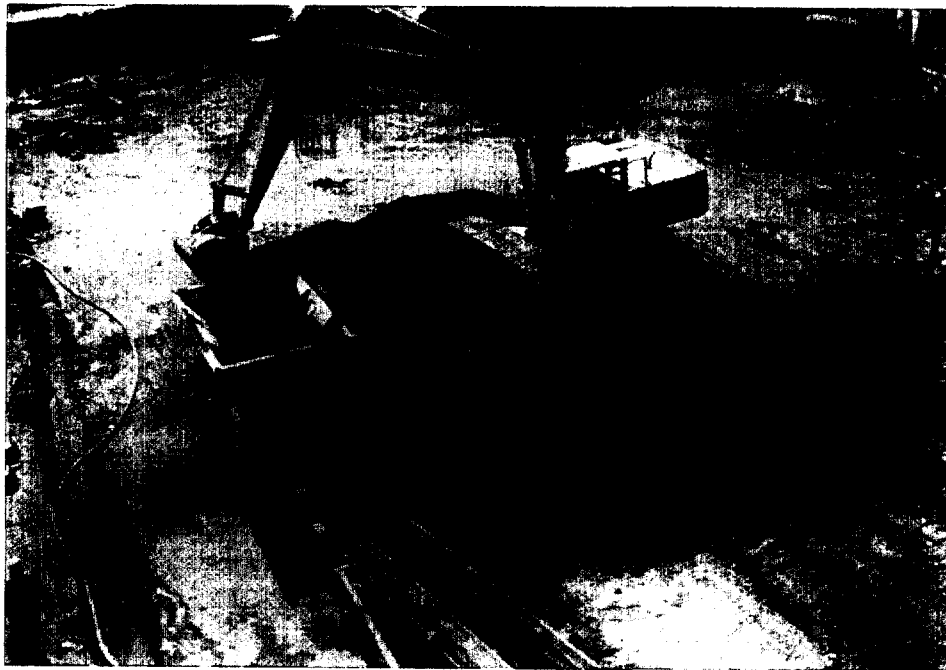
12. Belt feeder delivering hazardous soil at a consistent flow to the pugmill.

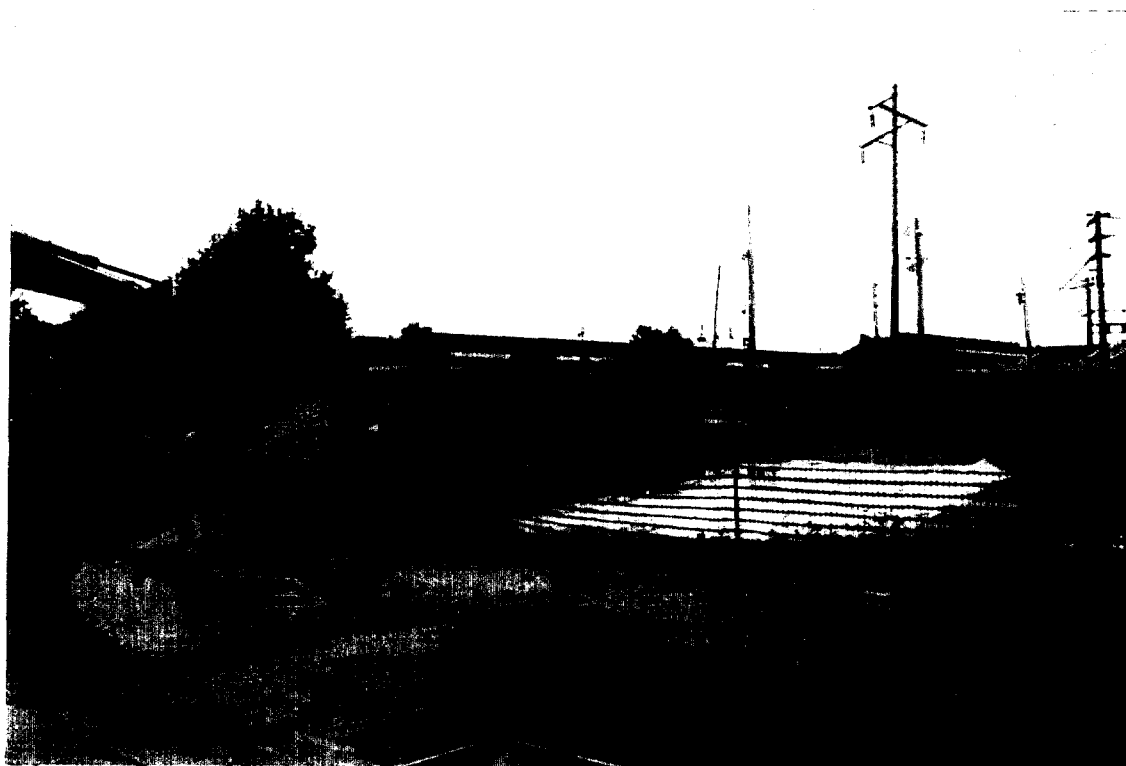
16. Recovery techs using foam seal product to shield stockpiles from weather (wind, rain, etc.)

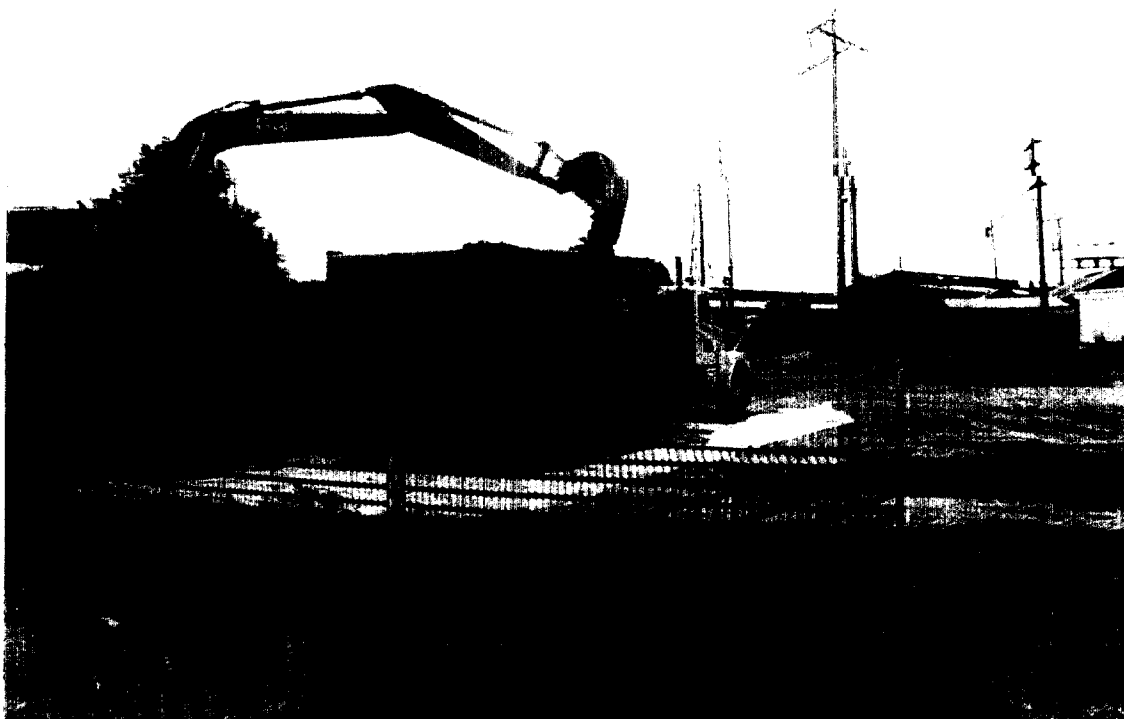
17. Cunningham Trucks hauling treated soil to Laidlaw, Roxanna.

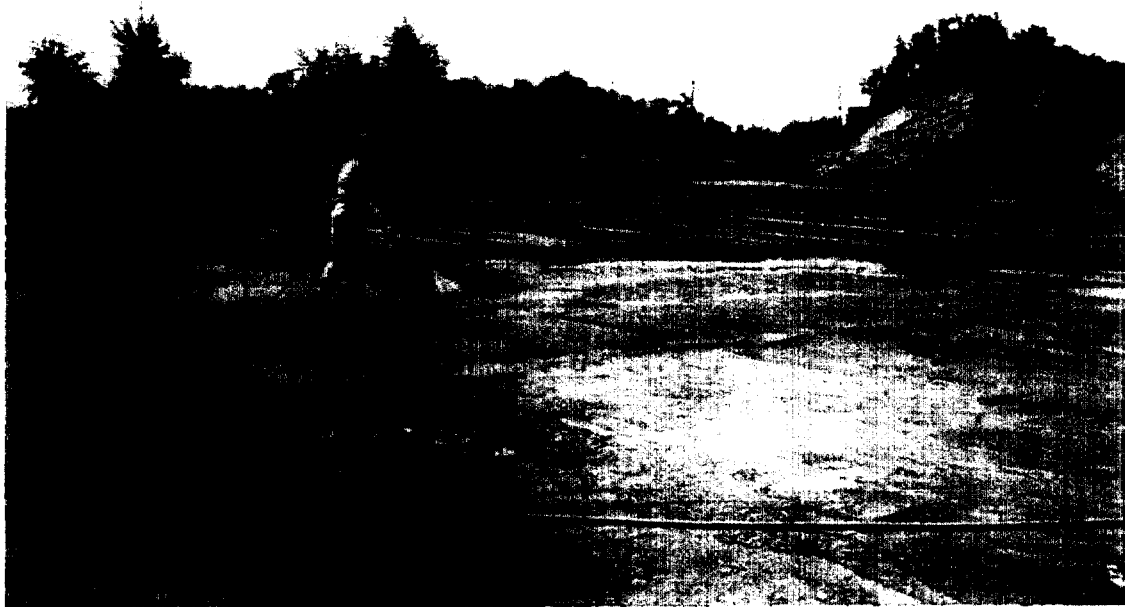
19. Recovery technician using a power washer to gross decontaminate hazardous side of stabilization pad.
